NSWC TR 79-259

**PRODUCTION AND ASSESSMENT OF DAMAGED
HIGH ENERGY PROPELLANT SAMPLES**

BY WAYNE L. ELBAN

8 MAY 1980

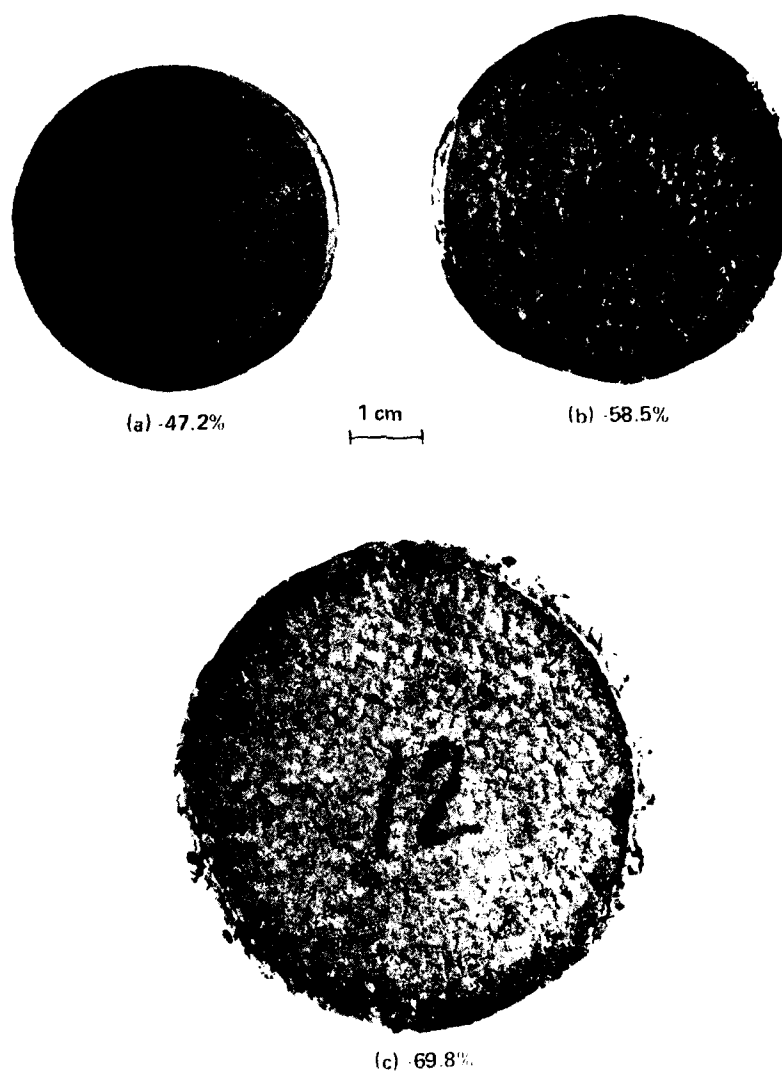
The results¹¹ for straining FKM, VOY-4, VMX-2J, and ALTU-16 in compression have been reported previously, and only a summary will be given, including some of the more interesting results. In general, the samples that had been mechanically deformed at the low strain rate used in this work did not exhibit extensive damage. Crack densities were found to be very low. The propellant exhibiting the most visible damage was FKM, and the cylinders subjected to the three highest strains appear in Figure 2. For this particular material, there were numerous cracks (see samples strained to -58.5 and -69.8%) at the casting grain boundaries. Very little cracking was visible in the cylinders of the remaining compositions. Longitudinal velocity measurements¹¹ one hour after compressing to various strain levels are given in Figure 3 for the various propellants. In each instance, there was a decrease in sound speed with increasing applied strain, although the rate of decrease differed markedly. Reductions in sound speed, by as much as 88%, were obtained for ALTU-16.

FIGURE 2 CYLINDRICAL CHARGES (41 mm DIA INITIALLY) OF FKX STRAINED IN COMPRESSION TO (a) -47.2%, (b) -58.5%, AND (c) -69.8%

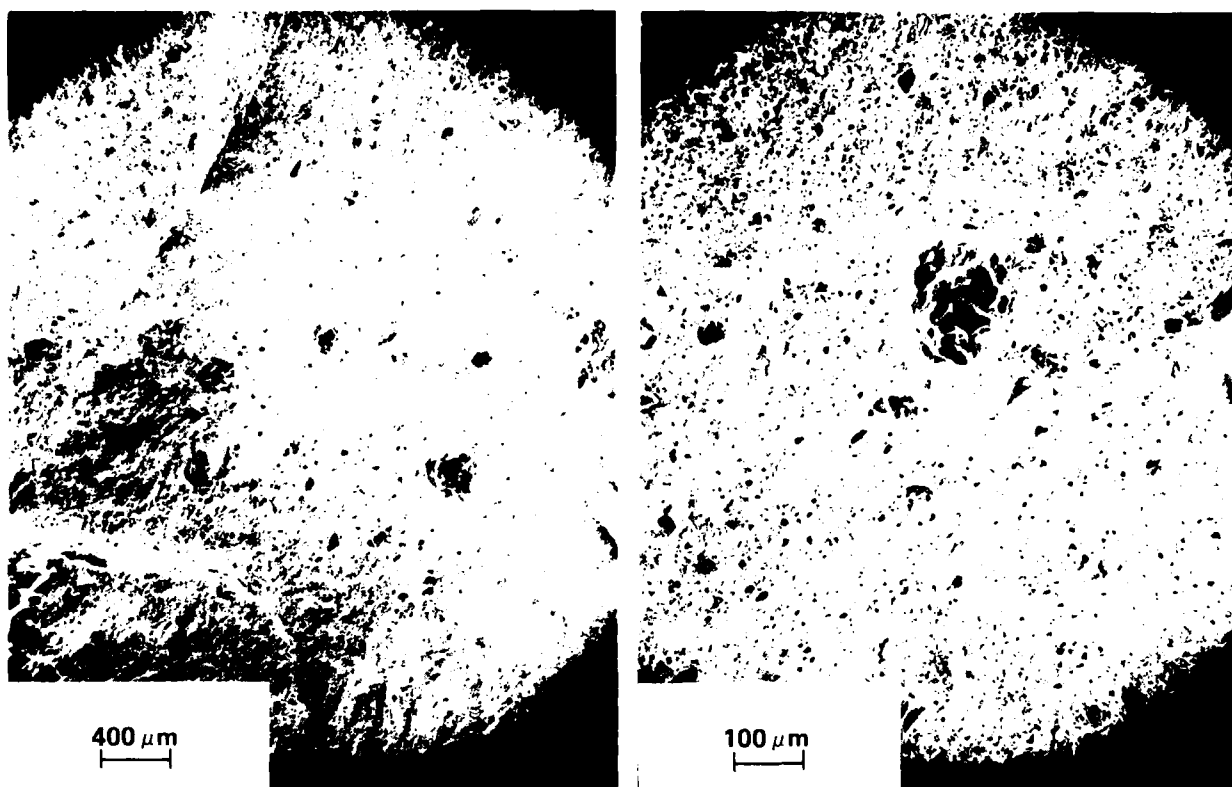
A number of interesting observations can be made from the SEM photomicrographs taken of material that had been immersed in liquid nitrogen. For comparison purposes, a microtomed cross-section of undamaged VRA-23 appears in Figure 6. The surface that results is monolithic in appearance with the largest exposed crystals (probably HMX) being about 200 μm . In a few instances, it appears that the cutting operation has caused debonding to occur at the binder-crystal interface. The fracture surface that results when a bare cylindrical charge of VRA-23 is immersed in liquid nitrogen is shown in Figure 7. Although this surface reveals more topographical detail than the microtomed surface, it is still fairly flat and featureless. Additional cracks do not intersect this primary fracture surface, and there is little indication that dewetting has occurred. However, numerous pores having characteristic dimensions ranging from 5 to 15 μm can be observed. The origin of these pores is not definitely known, but it is felt some water soluble ingredient (probably ammonium perchlorate) has been leached from the surface while the sample warmed to room temperature. It was observed that almost immediately after removal from liquid nitrogen, the sample fragments became covered by ice which eventually melted and ran off.

FIGURE 7 SEM PHOTOMICROGRAPHS OF FRACTURE SURFACE OF VRA-23 THAT
RESULTED WHEN BARE CHARGE WAS IMMERSSED IN LIQUID NITROGEN

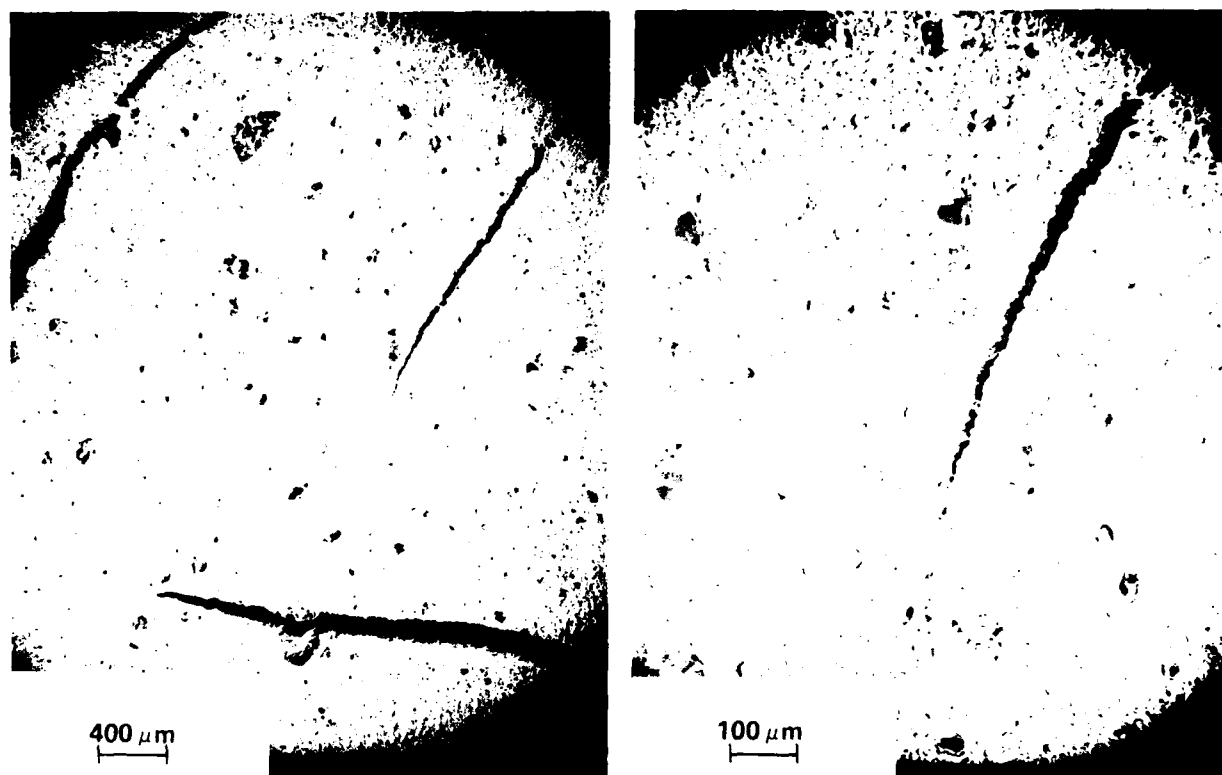
A microtomed cross-section approximately 1 mm behind the primary fracture surface generated during immersion in liquid nitrogen is displayed in Figure 8. Several cracks that did not extend to an exterior surface are visible. These cracks are straight and have smooth surfaces, exhibiting a largely brittle character. The porosity noted in the fracture surface displayed in Figure 7 was not observed in this cross-section, indicating that this porosity is a surface phenomena that does not occur in the bulk material. Perhaps the most interesting feature in Figure 8 (see bottom portion of lower magnification photomicrograph) is the crystal (believed to be HMX) that was fractured as a crack propagated through the propellant. Clearly, for these sample loading conditions, the binder-particle interfacial bond exceeded the tensile fracture stress of the HMX crystal. Evidence for fracture of HMX crystals was also obtained from examining recovered VRA-23 propellant that had experienced high strain rate impact by a flyer plate.⁵ However, the propellant fracture surfaces that resulted in these experiments do not reveal nearly as much brittle character as those obtained in the present work. It is concluded that the fracture obtained by bare charge immersion in liquid nitrogen was too severe to be useful in subsequent DDT experiments or comparison sensitivity tests.

FIGURE 8 SEM PHOTOMICROGRAPHS OF MICROTOMED SECTION APPROXIMATELY 1 mm BEHIND PRIMARY FRACTURE SURFACE OF VRA-23 THAT RESULTED FROM LIQUID NITROGEN QUENCHING

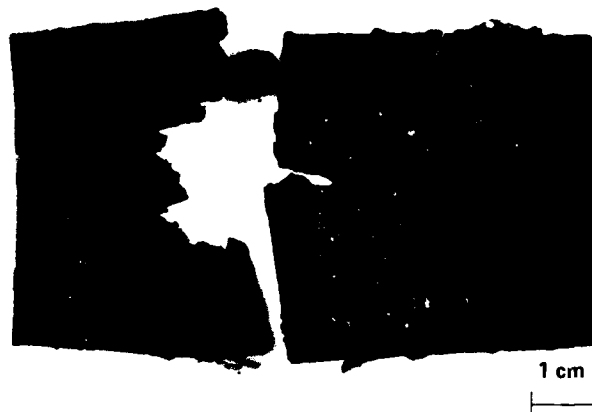
The VRA-23 propellant recovered from the aquarium experiment was heavily fragmented into granules and pieces of various sizes. The two largest pieces appear in Figure 9. Visual inspection of this material revealed that extensive cracking had occurred. The cracks exhibited considerable tortuosity and were unlike the straight faceted cracks associated with thermal stressing, as seen in Figure 5. The exposed fracture surfaces were rough indicating that the cracking was non-brittle. Residual strain and longitudinal sound velocity measurements (in the thickness dimension) were made on perimeter and center regions of the larger recovered piece. These results are listed in Table 3. Each region had a small compressive residual strain, while the longitudinal velocity was found to increase slightly. An increase in longitudinal sound velocity was observed similarly (see Figure 3) for VMX-2J and ALTU-16 having small compressive residual strains obtained by mechanical stressing.¹¹ It is important

FIGURE 9 LARGEST PIECES (INITIALLY 50 x 50 mm) OF VRA-23
RECOVERED FROM AQUARIUM SHOT

Of all of the samples examined in this work, the damage was most extensive in the propellant recovered from the aquarium shot. The small compressive residual strain and the slight increase in longitudinal velocity suggest that the samples experienced a small applied compressive stress and that dewetting did not occur. Apparently, there was increased intimacy at the binder-filler interface, and yet considerable tearing and rupture occurred. This is difficult to resolve considering the sequence of events leading to failure in composite solid propellants given in Appendix A. The most likely explanation lies in the fact that, for the aquarium experiment, the deformation occurs at high strain rate (estimated to be greater than 10^4 s^{-1}). In addition, the strain rate sensitivity of the material is probably such that the elongation at break is very low for the loading conditions of this experiment. Thus, the possibility for dewetting to occur is virtually eliminated. Analogous to propellant exposed to liquid nitrogen, the deformation leading to fracture in propellant recovered from the aquarium shot must be localized also, leaving sizable portions of relatively undisturbed material for the sound velocity measurements that were obtained. The failure pattern observed in Figure 9 is not consistent with any of the conventional compression failure modes¹⁵:

plastic yielding, cone failure, and axial splitting. The reason for this is not readily understood. Fracture caused by out-gassing of reaction products from an early stage shock-induced burning reaction in the bulk propellant is one possible explanation. Damage associated with postshock impact may have occurred also.

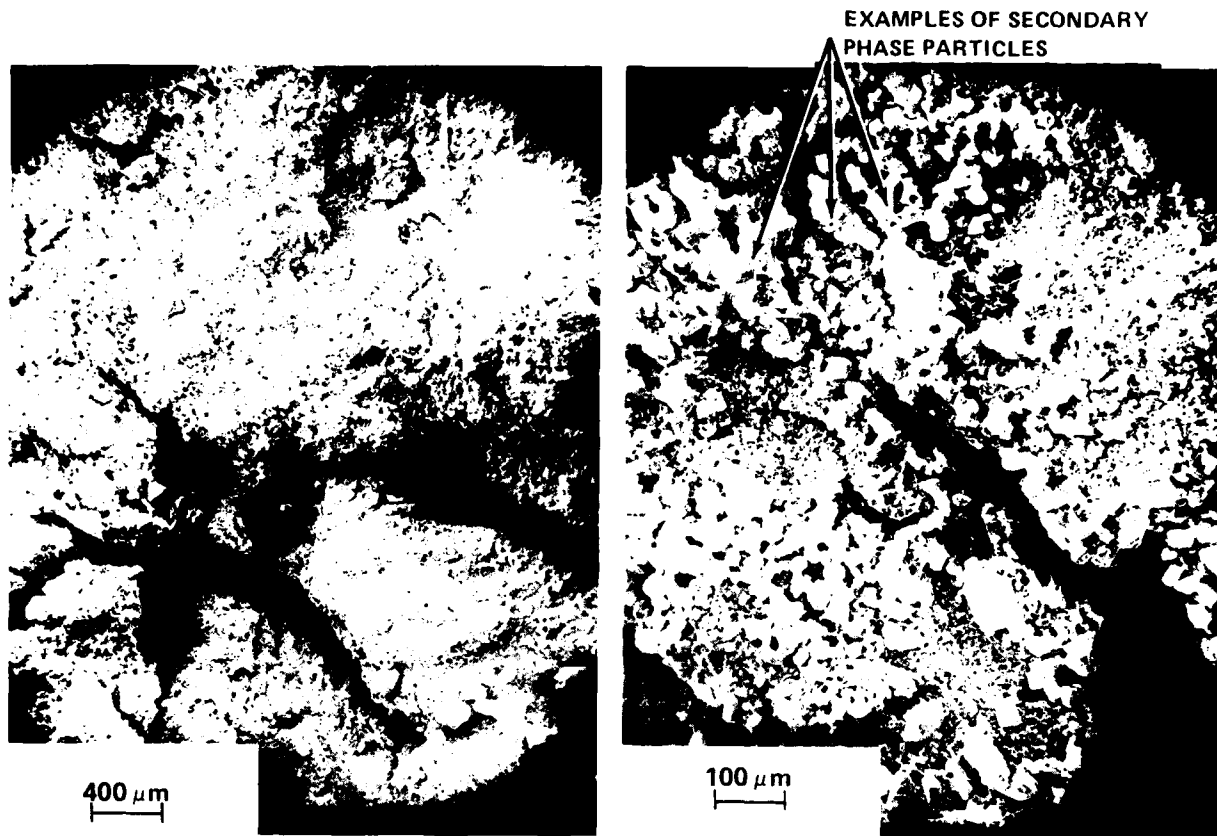
Some SEM photomicrographs were obtained, allowing several additional interesting observations. An exposed fracture surface is displayed in Figure 10. Considerable roughness is evident along with numerous secondary cracks intersecting the primary fracture surface. Interfacial bond failures are visible in a few instances, although there is a lack of discernible filler particles. Light gray secondary phase particles are also conspicuous, particularly in the higher magnification photomicrograph. The origin of these particles is not known. They may be reaction products from an early stage burning reaction (see SEM photomicrographs of burned propellant surfaces that were extinguished obtained by Derr and Boggs)¹⁴ or corrosion products resulting from the fractured material being exposed to the aqueous environment. Additional attempts to locate secondary phase particles on exposed fracture surfaces from other regions of the samples were unsuccessful.

FIGURE 10 SEM PHOTOMICROGRAPHS OF EXPOSED FRACTURE SURFACE OF VRA-23
RECOVERED FROM AQUARIUM SHOT

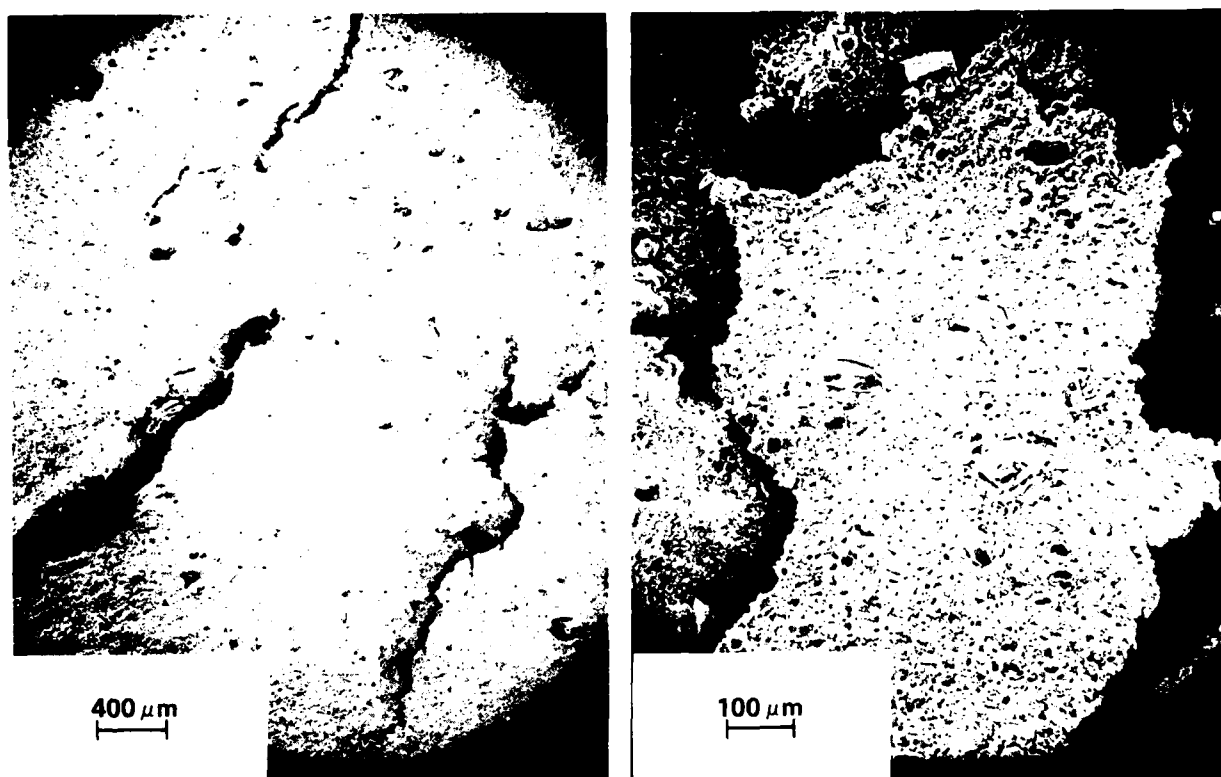
A microtomed cross-section approximately 1 mm behind the primary fracture surface appears in Figure 11. The tortuous character of the cracks is quite visible, but no secondary phase particles could be found. Further, there was no other indication that a burning reaction had occurred in or near the cracked regions. The fracture surface of a non-exposed "zero-width" crack is shown in Figure 12. This surface closely resembled the one appearing in Figure 10, except for the absence of secondary phase particles. Thus, it appears that the presence of the secondary phase particles is highly localized. In addition, no fractured HMX crystals were observed in any of the photomicrographs taken of propellant recovered from the aquarium test.

FIGURE 11 SEM PHOTOMICROGRAPHS OF MICROTOMED SECTION APPROXIMATELY 1 mm BEHIND PRIMARY FRACTURE SURFACE OF VRA-23 RECOVERED FROM AQUARIUM SHOT

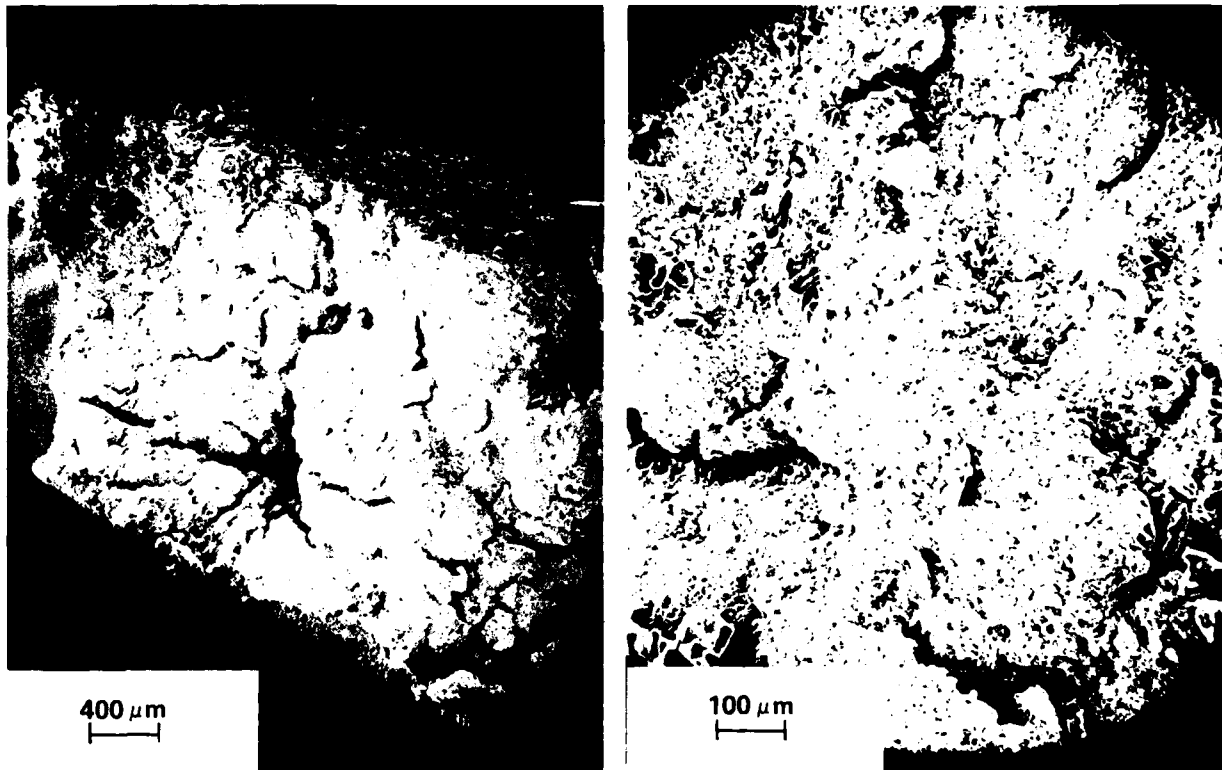
FIGURE 12 SEM PHOTOMICROGRAPHS OF NON-EXPOSED FRACTURE SURFACE OF VRA-23
RECOVERED FROM AQUARIUM SHOT
